**NBSIR 74-474**

# **Metallurgical Analysis of Wear Particles and Wearing Surfaces**

Metallurgy Division  
Institute for Materials Research  
National Bureau of Standards  
Washington, D. C. 20234

Final Report  
NAONR-31-73  
NR 229-014

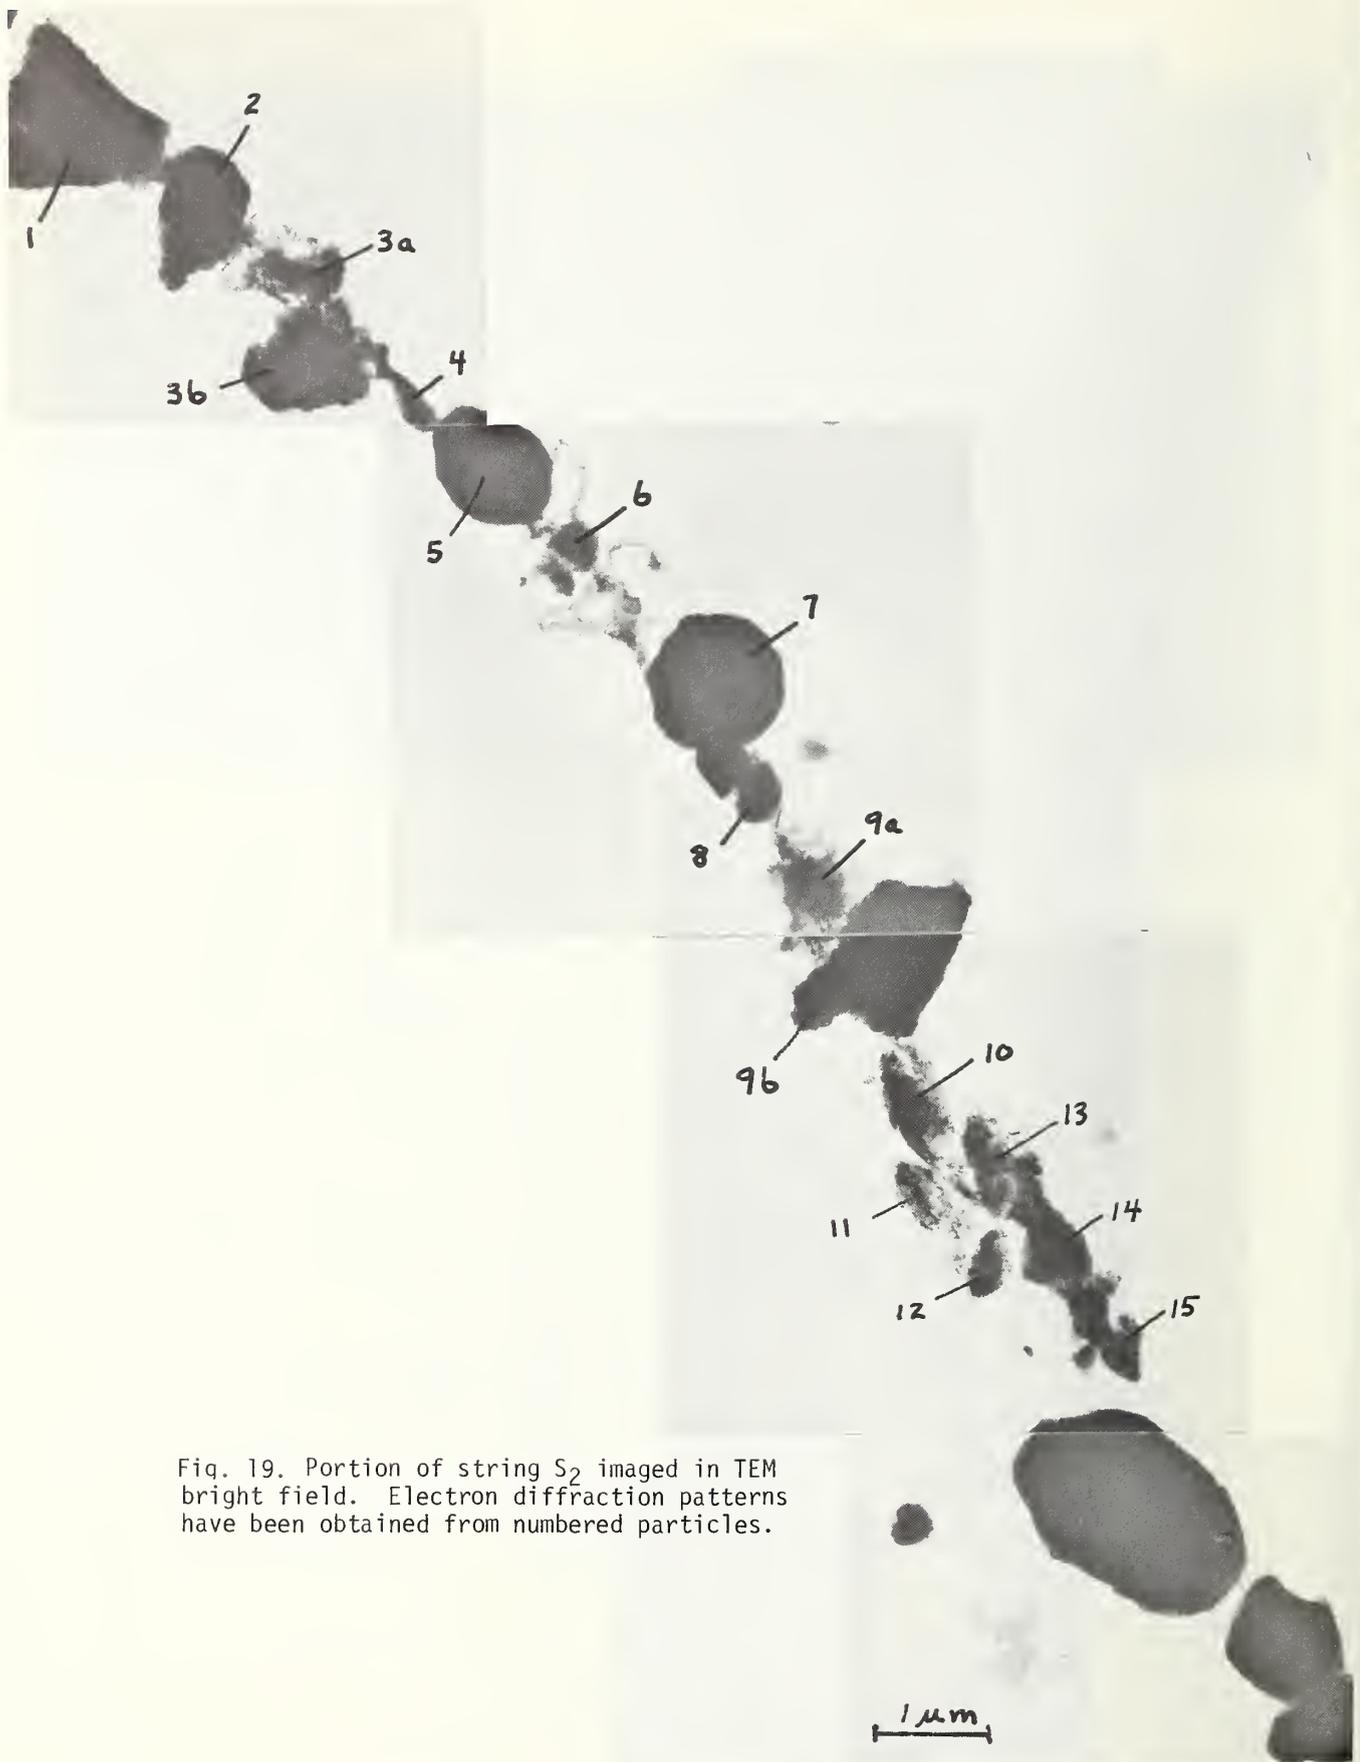
Fig. 19. Portion of string  $S_2$  imaged in TEM bright field. Electron diffraction patterns have been obtained from numbered particles.

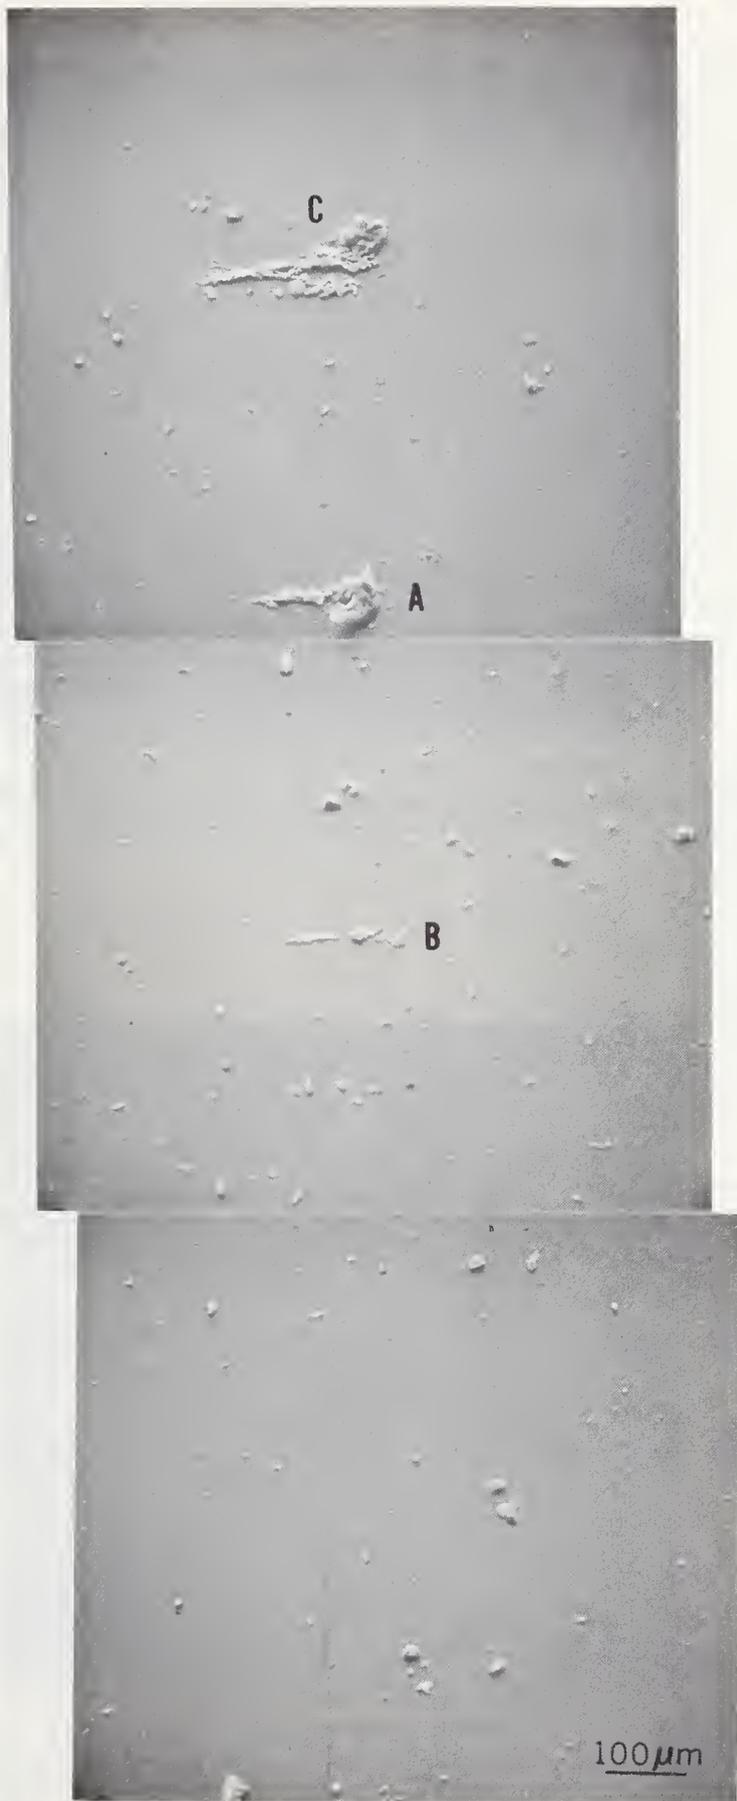
Fig. 20. Ferrogram 2119 from single ball test run. Initial particle deposit is at C. Flow is downward. M = 100x.

A series of oil samples from a test of an M50 steel (includes 4% Cr, 4% V) ball and race was obtained by Trans-Sonics and processed to produce several Ferrograms. A silicon-bronze ball retainer was included in the mechanical testing device. The oil was MIL-L-23699 type held at a temperature of 300°F. The test involved a time-to-failure of 9h 55m and a ball Hertz stress of 600 kpsi maximum. At failure the ball became driven into the retainer. The Ferrogram (F-2119) was prepared using carbon precoated slides from an oil sample taken at 8h time (1h 55m prior to failure).

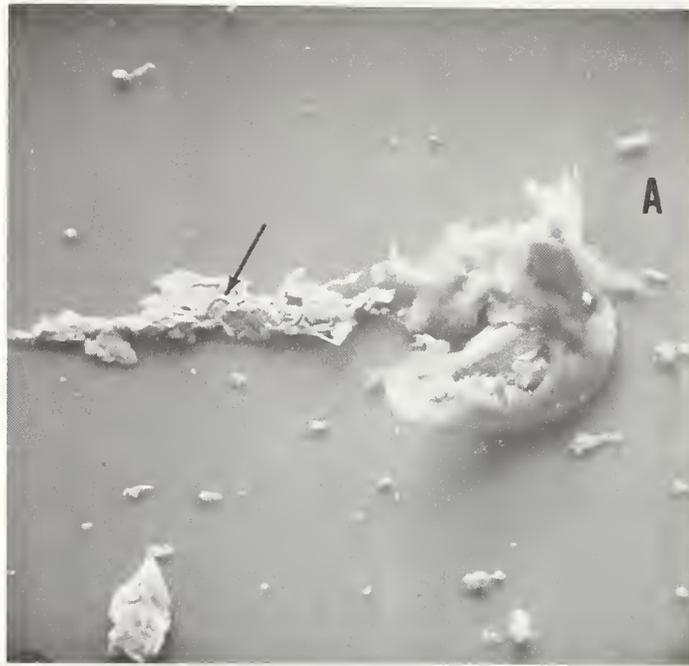
Fig. 21(a); Region A from above shows string containing flake-like particles and several examples of ribbon-like particles. M = 500X.

Region A in Fig. 20 is shown again in Fig. 21. Several examples of long ribbon-like particles are found in that string together with some flake-like particles. Both types have surface structures and markings that suggest plastic deformation and slip bands. X-ray analysis results are given. Figure 21 shows the region B in more detail. One

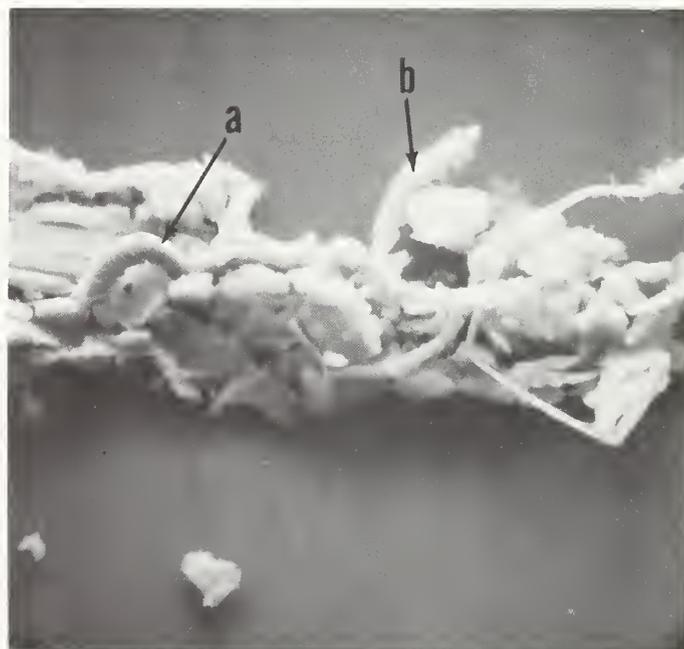
(b). Details of ribbon-like particles in above string. Note apparent deformation markings on ribbon (a). Both ribbons indicated are alloy steel with principal elements Fe(9,300 cts), Cr(3,200 cts) and Ni(1,000 cts). Ribbon (b) also contains Cu. M = 2,000X.

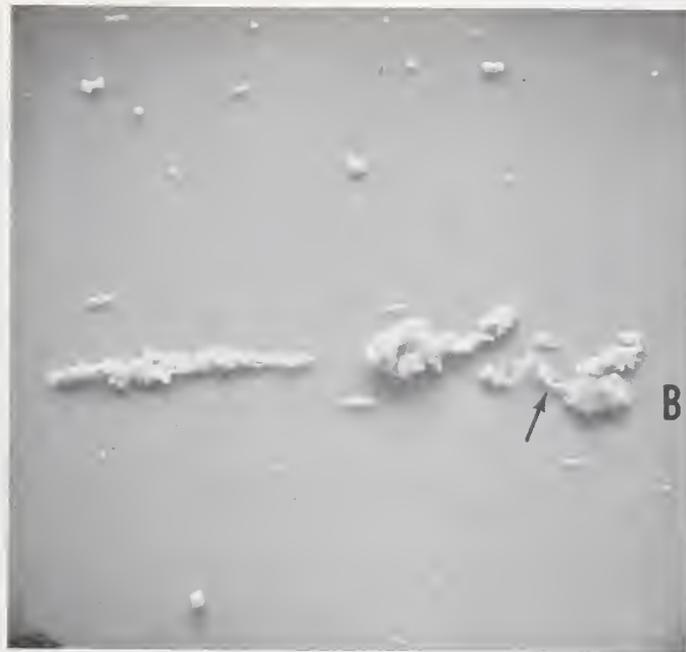
Fig.22(a). Region B from above. Several small particle strings are present. M = 500X.

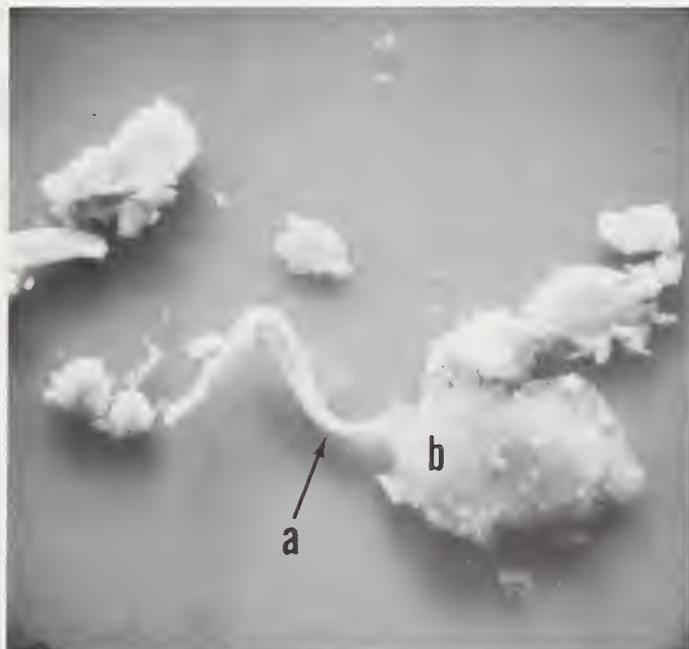
(b). Details of ribbon-like particle in above string (a), containing Fe, Cr, and Ni. Blob (b) contains only Fe, about 40% that of (a) plus oil residue and is probably iron oxide. M = 2,000X.

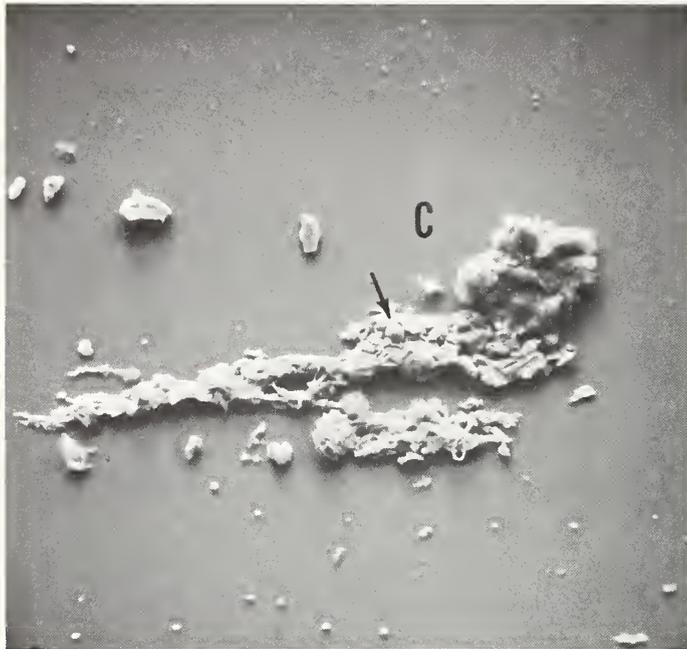
Fig. 23(a). Particle strings in Region C of above. Flake and ribbon-like particles and one spheroid (arrow) are seen.  $M = 300X$ .

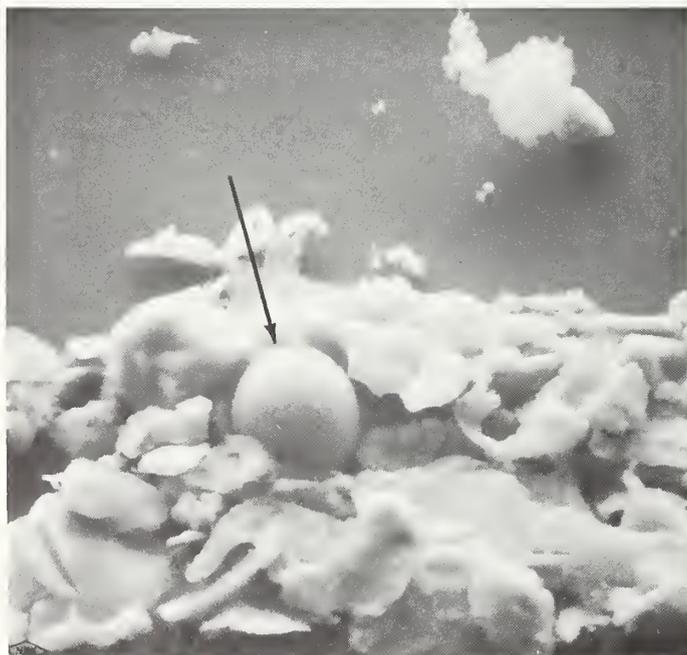
(b). Details of above string and spheroidal particle of  $8 \mu\text{m}$  diameter.  $M = 2,000X$ .

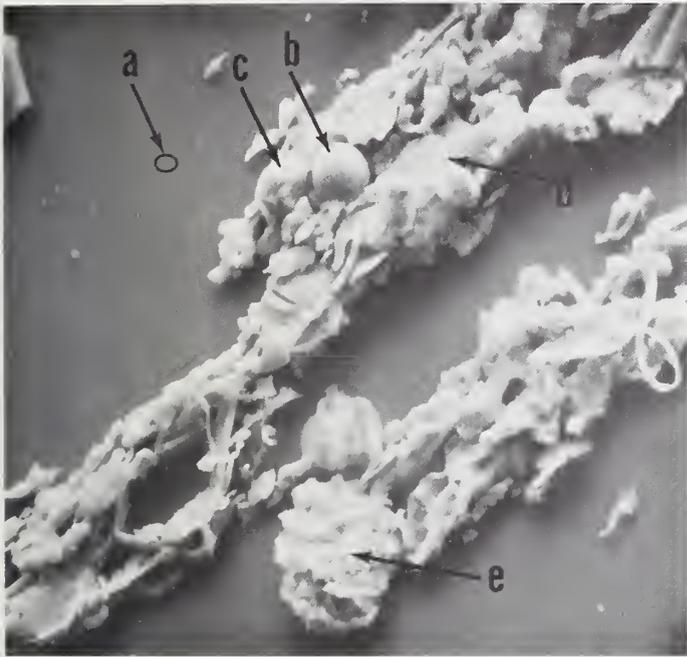
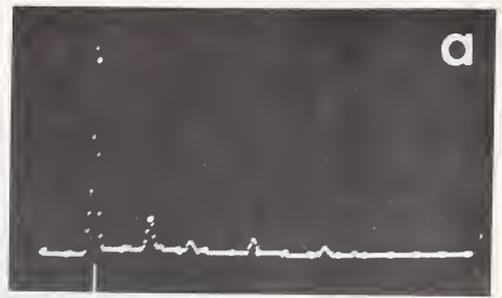
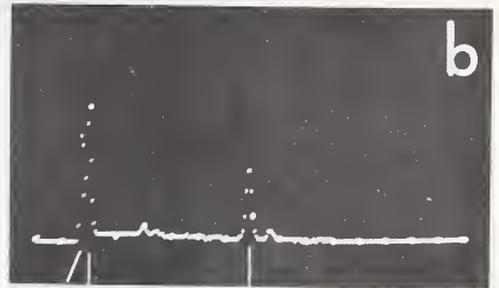
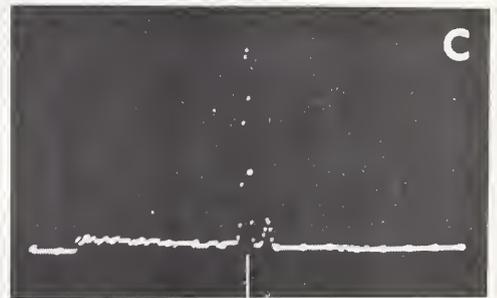
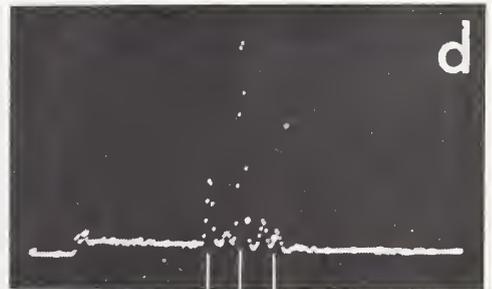
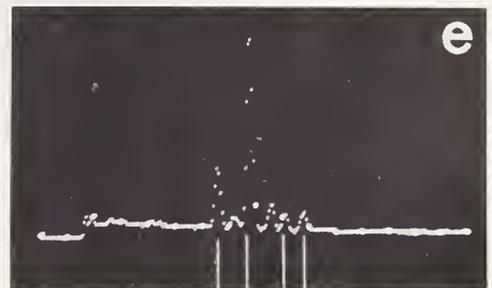
Fig. 24. Area of above with X-ray emission analyses shown for labeled particles and background (a). Spheroidal particle (b) has considerable Si, Al, and Fe content. Particle (c) is principally iron while particle (d) has substantial Cr and Ni content indicating alloy steel particle. Particle (e) contains Cu in addition. M = 1,000X.

In summary, only one spheroid has been found among the particles from this single ball test. It is relatively large and it contains significant amounts of silicon and aluminum. There is no appearance of a rough or cracked oxide covering on the sphere. Adjacent particles in the string that show a greater roughness do not show any significant silicon content. The ribbon-like particles found in this Ferrogram are typical cutting-wear particles.

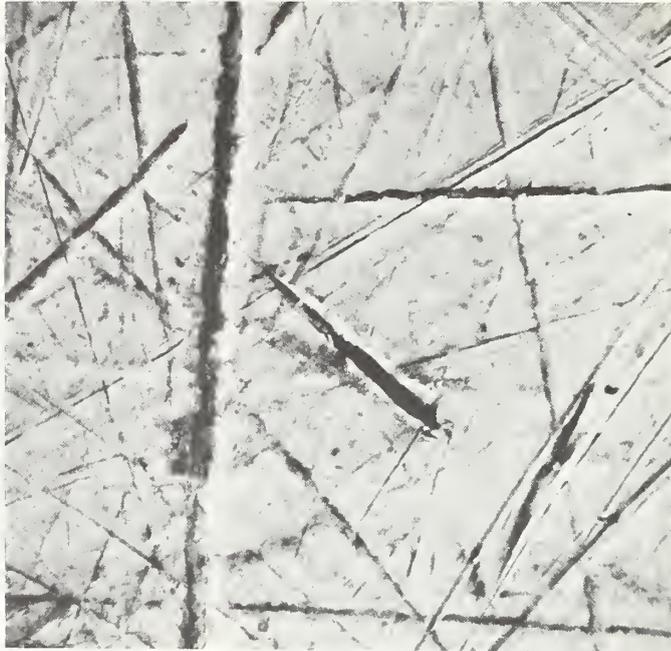
Fig. 25(a). Surface of bearing ball, 11/16 inch diameter, 52100 steel, after bearing bench test. Wear and gouge tracks are seen in SEM photo. M = 3,000x.

A disassembled bearing that had failed during a bench test at SKF was examined to attempt to relate the particle debris obtained by the Ferrograph from the lubricating oil with the bearing surface structures and markings. An example is shown in Fig. 25 taken from one 52100 steel bearing ball. Some of the surface tracks seen in Fig. 25a may remain from initial finishing operations, however, many examples of deep wear gouges are present. Detailed examination indicated that plastically deformed metal at the gouge rim can be detached in the form of small particles (Fig. 25b). Larger particles may also form in this way as indicated by the 3 $\mu$ m particle formed in Fig. 26. Note the surface markings on the particle and the similarity with the bulk surface markings. This particular gouge appears to be

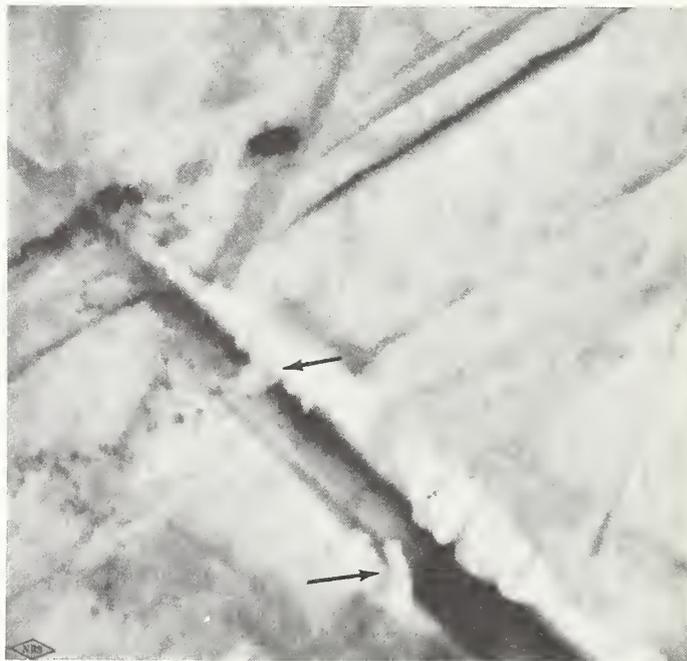
(b). Details of metal deformed over gouge rim. Several particles appear to be forming. M = 12,000x.

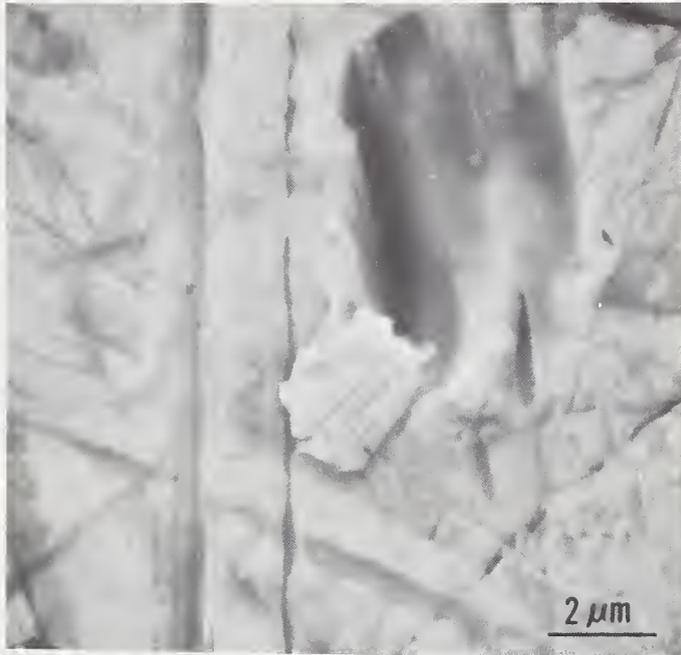
Fig. 26. Particle formed at edge of gouge on ball surface. Note surface wear markings on particle.  $M = 7,000\times$ .

abrasively formed and the particle is formed from the edge displaced metal. The degree of plasticity of the surface material is apparent. Endo and Kotani<sup>14</sup> have recently reported similar topographic observations on steel surfaces wearing under lubricated sliding conditions.

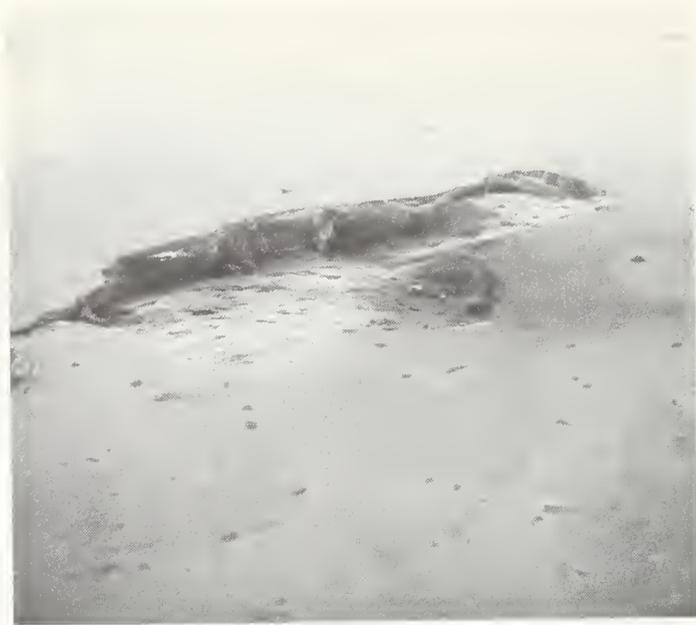
Fig. 27(a). Surface spall on ball from failed bearing.  
M = 60x.

This ball was obtained from a failed bearing supplied by the Naval Ships Engineering Center and previously studied at Trans-Sonics. A spall occurred on the ball surface whose appearance (Fig. 27a) is typical of that type of damage. Considerable subsurface cracking is seen in this example extending away from the exposed fracture surface. The fracture surface morphology suggests that some plastic behavior occurred, perhaps after the spall fragment was produced. Many leaf-like protrusions remain on the surface, perhaps as a source of additional wear particles during subsequent contacts and motion. Several spheroidal particles were located on this surface, and a stereo-pair of SEM photographs of them is shown in Fig. 28. These spheres are not solid, metallic particles, however, since the X-ray emission peak intensity is considerably less than that obtained from the background and from other particles on the surface. They appear to be composed of iron and organic constituents.

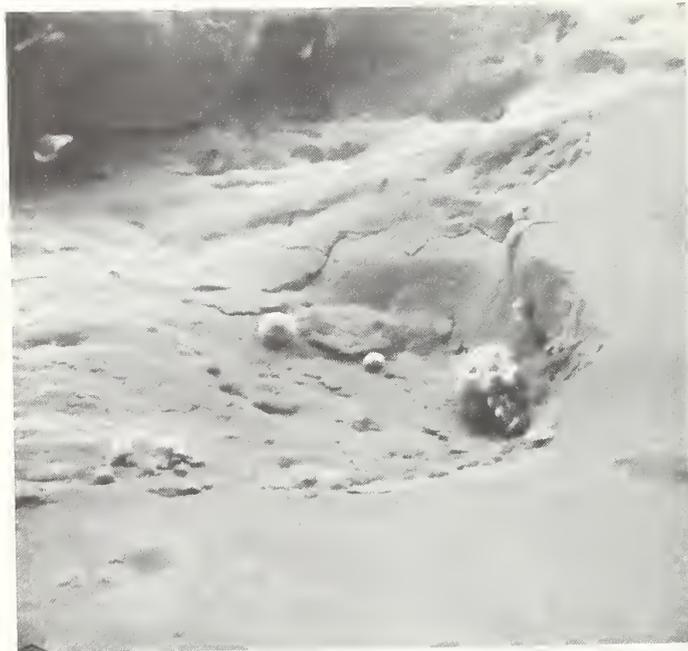
(b). Edge of above spall showing fracture surface features and spheroidal particles on surface. M = 240x.

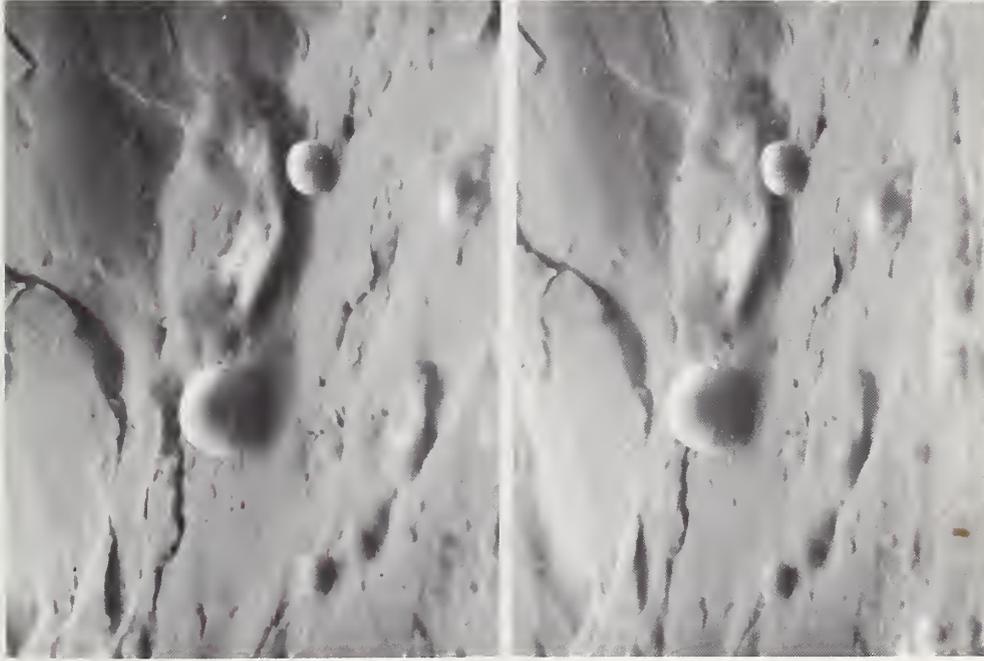
Fig. 28. SEM stereo photographs of above spheroidal particles on spall surface. Upper and lower views form right-left stereo pair, respectively.  $M = 600x$ .
